**CROTON-HARMON UFSD**  
**2015 BUILDING CONDITION SURVEY**  
**PIERRE VAN CORTLANDT MIDDLE SCHOOL**  
**SED # 66-02-02-03-0-002**

**Croton-Harmon UFSD  
2015 Five Year Plan  
Pierre Van Cortlandt Middle School**

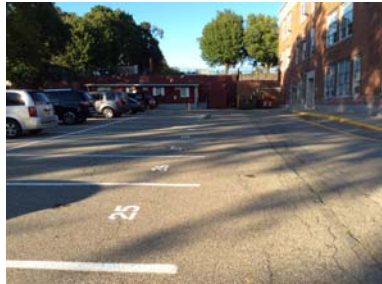
**SS 2 Asphalt Paving:**  
Repave upper parking lot with new asphalt paving.

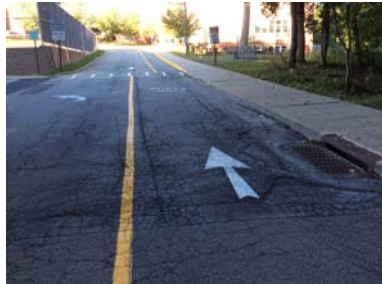
**SS 2 Asphalt Paving:**  
Repave lower parking lot and bus loop with new asphalt paving.

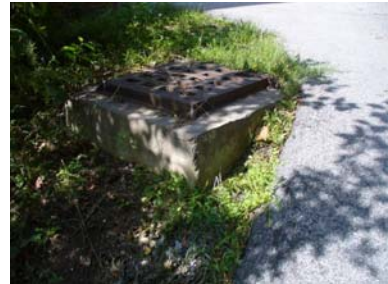
**SS 4 Cafeteria Path Site Drainage:**  
Current storm grate elevations are set above grade and do not intercept storm water. Work includes adjusting grate elevations to complement new cafeteria path design

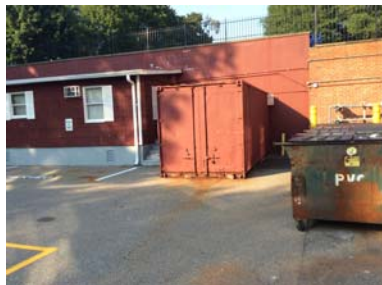
**SS 6 Site Storage**  
The State Education Department requires storage containers to be provided with ventilation and door hardware that can be opened from the inside without a key.

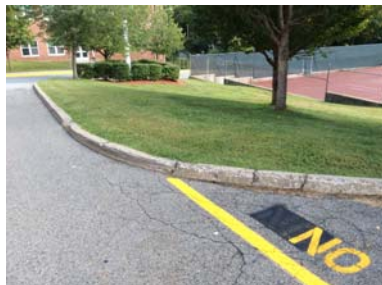
**SS 7 Concrete Curbs:**  
Replace broken concrete curbs.

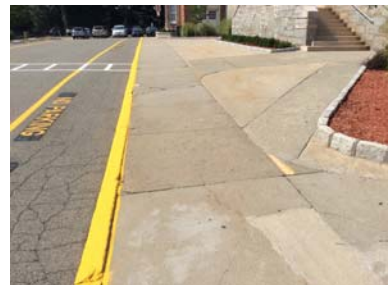
**SS 8 Concrete Sidewalks**  
Replace cracked and broken concrete sidewalks.

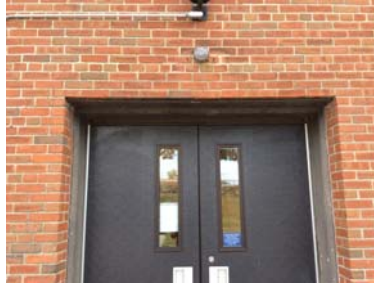
**EB 2 Replace Rusted Lintels**  
Lintel at the 1939 Gymnasium is starting to expand due to rusting. Lintel should be replaced before it expands further and cracks the brick veneer.

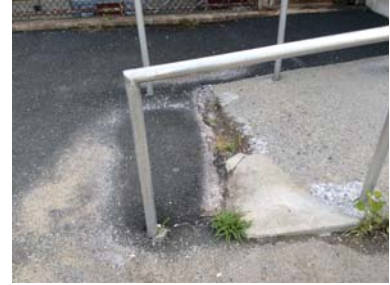
**EB 5 Concrete Ramp**  
Surface of concrete ramp is badly deteriorated. Recommend removing and replacing ramp and stairs with new concrete ramp and stairs.

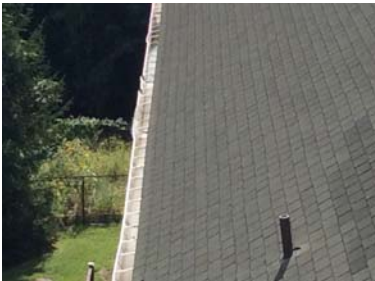
**EB-6 Metal Gutter**  
Metal gutter at 2004 addition is damaged from debris collecting and clogging gutter. Recommend replacing damaged gutter with new gutter with protective covering.

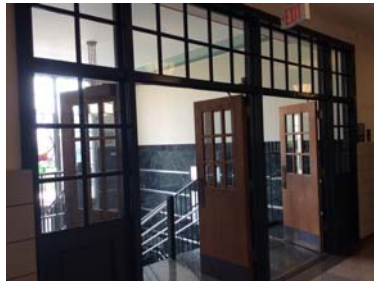
**BIC 1 Wire Glass**  
Wire glass is no longer allowed by the State Education Department. Although replacement is not mandatory, it is recommended that large areas of glass be replaced with approved safety glazing as time and budget permit.

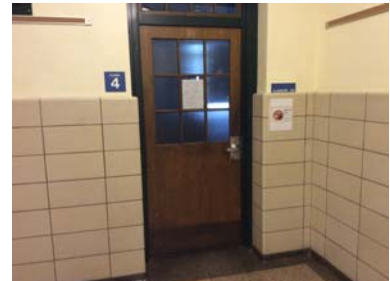
**BIC 2 Interior Wood Doors**  
Interior wood doors are at the end of their useful life. Fatigue at the hinges and latch hardware is causing the doors to stick or not latch properly. Replacement is recommended.

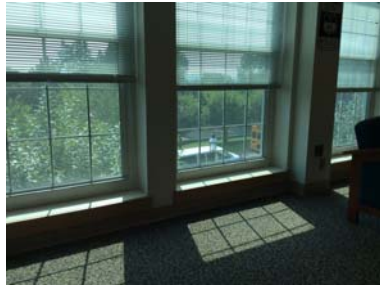
**BIC 3 Library Windows**  
Operable windows at Library are at floor level and provide no fall protection when open. Recommend adding safety railings to the windows, and adding stops to limit window opening

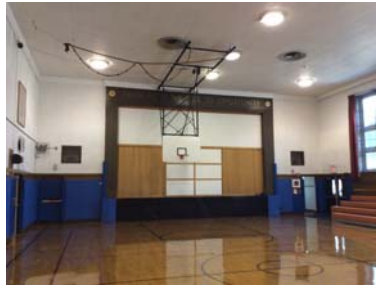
**BIC 4 Wood Gymnasium partition**  
The wood partition between the gymnasium and adjacent classroom does not provide the fire separation as required by current New York State Building and Fire Code. Work would include the removal and replacement of the wall with fire-rated construction.

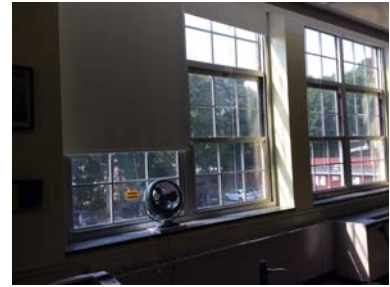
**BIC 5 Rescue Windows**  
Window treatments at rescue windows should be labeled with rescue window labels

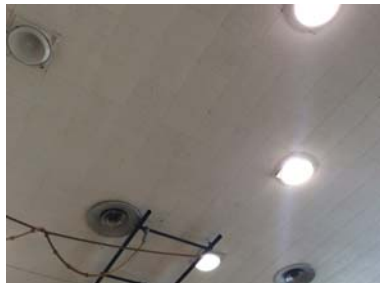
**BIR 1 Gymnasium Ceiling**  
1939 Gymnasium ceiling has many tiles that are loose, damaged and falling down. Replacement of ceiling with impact resistant suspended ceiling system is recommended.

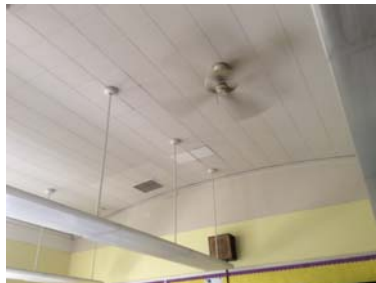
**BIR 2 Concealed Spline Ceilings:**  
Concealed spline ceilings were installed when the building was first built and restrict access above ceiling for maintenance. Work would include the replacement of these ceiling areas.

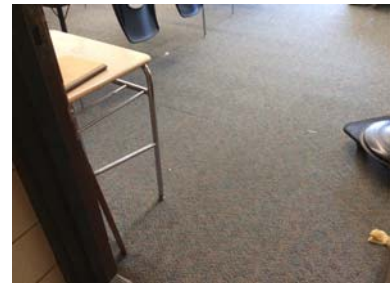
**BIR 3 Carpet:**  
Worn and stained carpet at the end of its useful life should be removed and replaced.

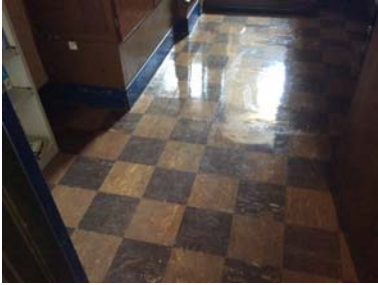
**BIR 10 Vinyl Asbestos Tile:**

Vinyl asbestos tile installed during the original construction of the building has served its useful life and requires replacement. Work would include removal of existing floor tile and rubber base and installation of new vinyl composite tile and rubber base.

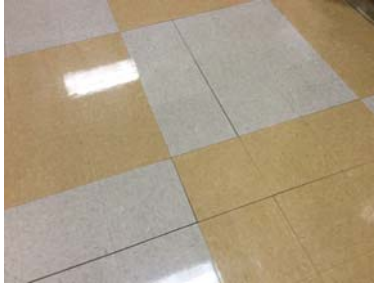
**BIR 11 Vinyl Composite Tile:**

Seams at the common area s vinyl composite tile in the 2004 addition are expanding and widening. Vinyl composite tile should be removed and replaced with new vinyl composite tile and wall base.

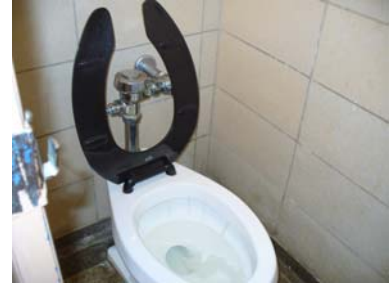
**BIR 12 Single Use Toilet Rooms**

Two single use toilet rooms on the third floor were abandoned during the domestic water replacement project. Work would be to reconnect fixtures to new domestic water piping to restore use of these toilet rooms

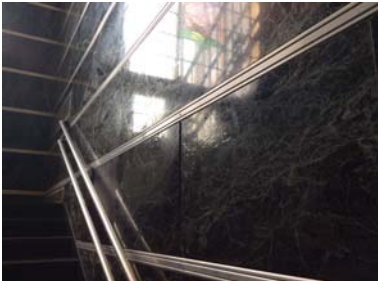
**BIR 13 Restore 1939 Building Lobby**

The marble panels and metal trim in the original entry lobby are from the original construction. Age has loosened and cracked the materials and requires work in order to preserve the original materials. Work would include the restoration and repair of the materials.

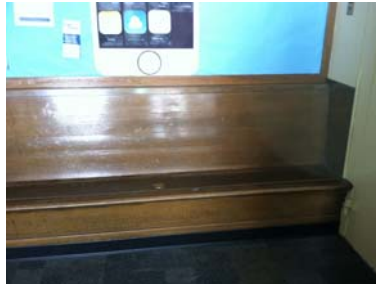
**BIR 17 Guidance Renovations:**  
The Guidance Department requires one more office to accommodate the current staff. Work includes renovating current location to provide one additional office

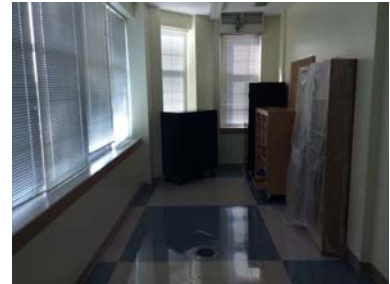
**BIR 18 Greenhouses:**  
Greenhouses in the 2004 addition were never finished. Work includes renovations to convert spaces into working greenhouses.

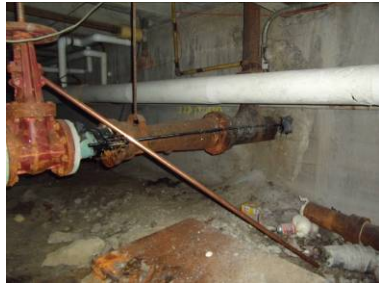
**P1 Water Service (1939 Building)**  
Replace existing domestic water service piping to building.

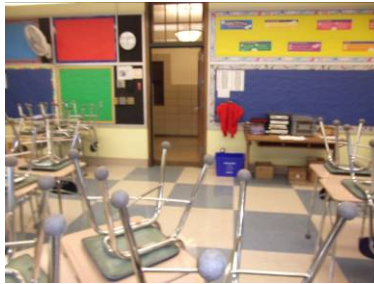
**E1 Add Computer Receptacles in 1939 classrooms:**  
Add additional 2 quad computer receptacles / classroom in 1939 building

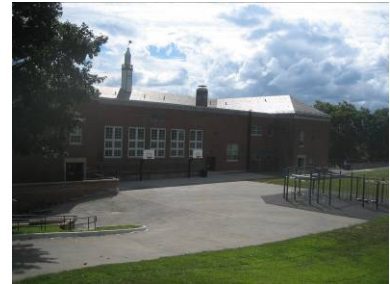
**E2 Add Site Lighting**  
Add site lighting between High School and Middle School

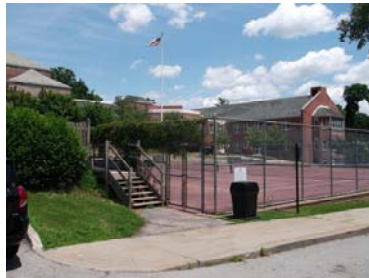
**E3 Add Site Lighting:**  
Add walkway lighting along tennis courts.

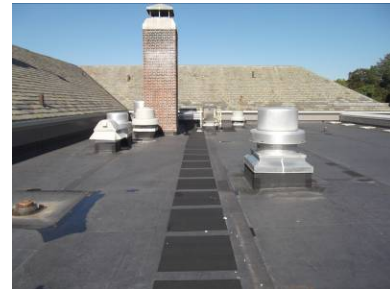
**M1 General Exhaust (1939 Building)**  
Replace existing rooftop exhaust fans.

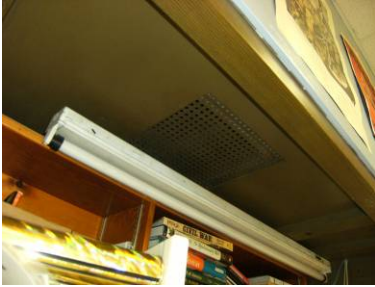
**M2 Exhaust Shaft Fire Stopping (1939 Building)**  
Provide fire dampers in existing exhaust shafts serving classrooms.

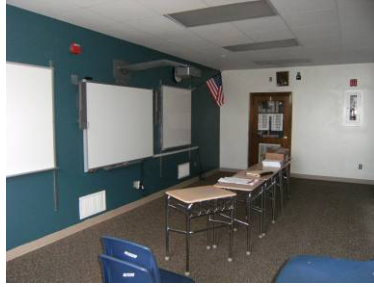
**M3 Rooms 223, 224, 307, 309, 319 (1939 Building)**  
Provide powered outdoor air and exhaust ventilation.

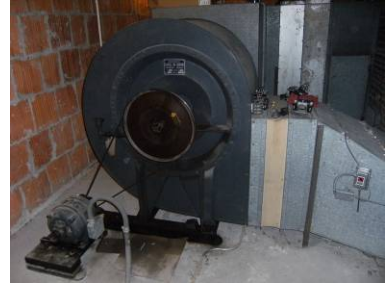
**M4 Gymnasium (1939 Building)**  
Replace existing Gymnasium ventilation fan.

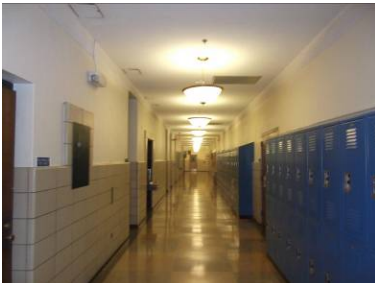
**M5 Corridors (1939 Building)**  
Provide powered outdoor air ventilation for all Corridors.

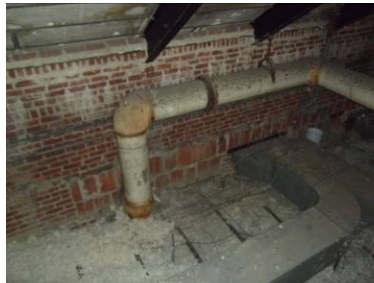
**M6 Heating Piping (1939 Building)**  
Replace existing steam and condensate piping.

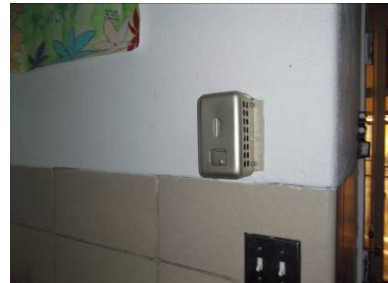
**M7 Controls (1939 Building)**  
Replace remaining pneumatic controls with DDC type and connect to existing BMS.

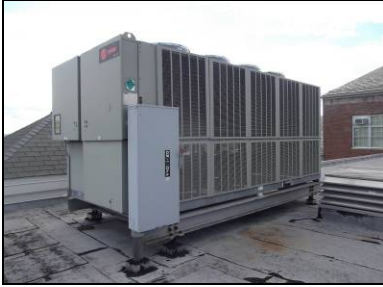
**M8 Air Conditioning (2004 Addition):**

Provide Cooling to minimum twelve (12) additional Classrooms which are currently not air conditioned by the chilled water system.

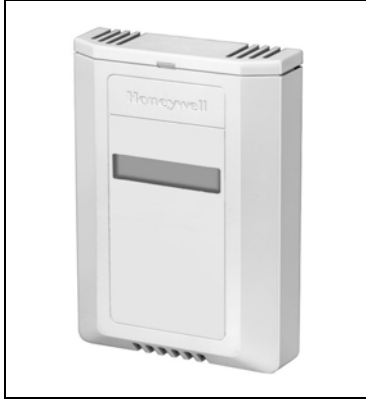
**M9 CO2 Monitoring:**

Provide CO2 wall sensors in Classroom spaces.

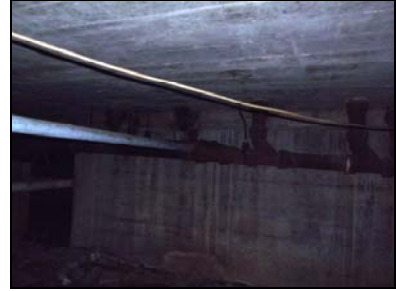
**M10 Crawlspace:**

Provide Powered Exhaust Ventilation.
