**CROTON-HARMON UFSD
2015 BUILDING CONDITION SURVEY
TRANSPORTATION DEPARTMENT
SED # 66-02-02-03-5-004**

Croton-Harmon UFSD 2015 Five Year Plan Transportation Department

KSO Project #15100020

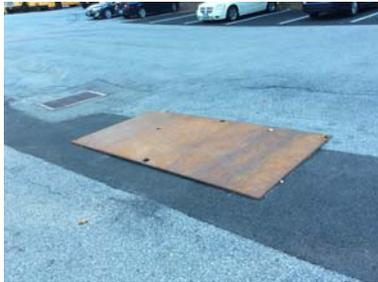
<p>SS 4 Underground storm Drainage: Portions of the underground drainage have collapsed and caused sink holes in the parking lot. Work includes excavation and replacement of underground storm water piping.</p>

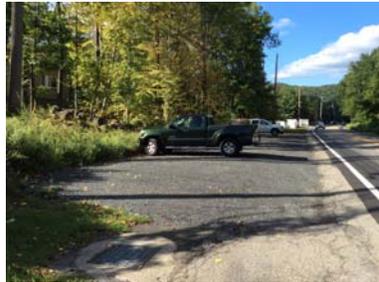
<p>SS 15 Site Parking Parking areas along route 129 cause a dangerous situation for drivers backing out into the road. Work includes paving and required grading to relocate additional parking on site away from the road.</p>

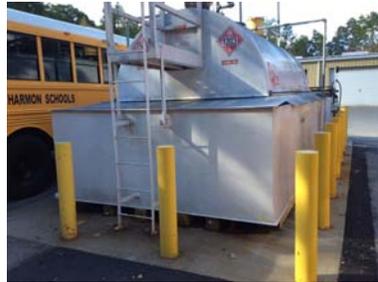
<p>SS 16 Fuel Tank The existing fuel storage/dispensing tank is at the end of its useful life and requires replacement.</p>

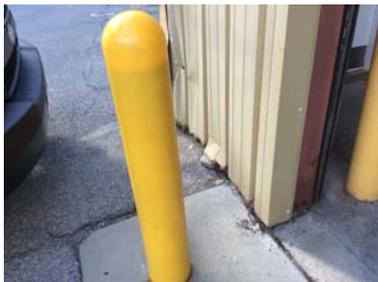
<p>EB 10 Metal Siding: replace The exterior walls of the transportation building are made of painted metal siding. Areas of the siding are damaged and rusted. Work includes replacing damaged and rusted sections of metal siding.</p>

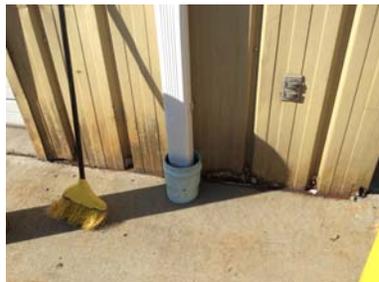
<p>EB 11 Metal Siding: Repaint The exterior metal siding of the original transportation building have never been refinished. Areas of the building are beginning to rust. Work includes repainting all of the metal siding of the original building to prevent further corrosion.</p>

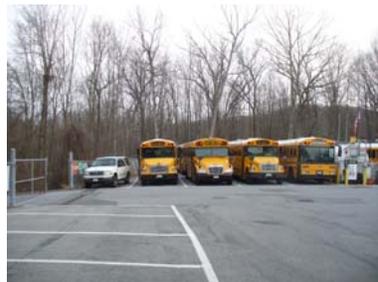
<p>P 17 The existing septic system continually requires maintenance to remain functioning. Additionally, the Department of Health does not allow for a septic system to be located under a paved parking area. Work includes replacement with a mound type system.</p>
